THE UNIVERSITY OF ALBERTA

A STUDY OF DELAYED FAILURE OF A CUT SLOPE IN STIFF CLAY

A THESIS

FALL 1978

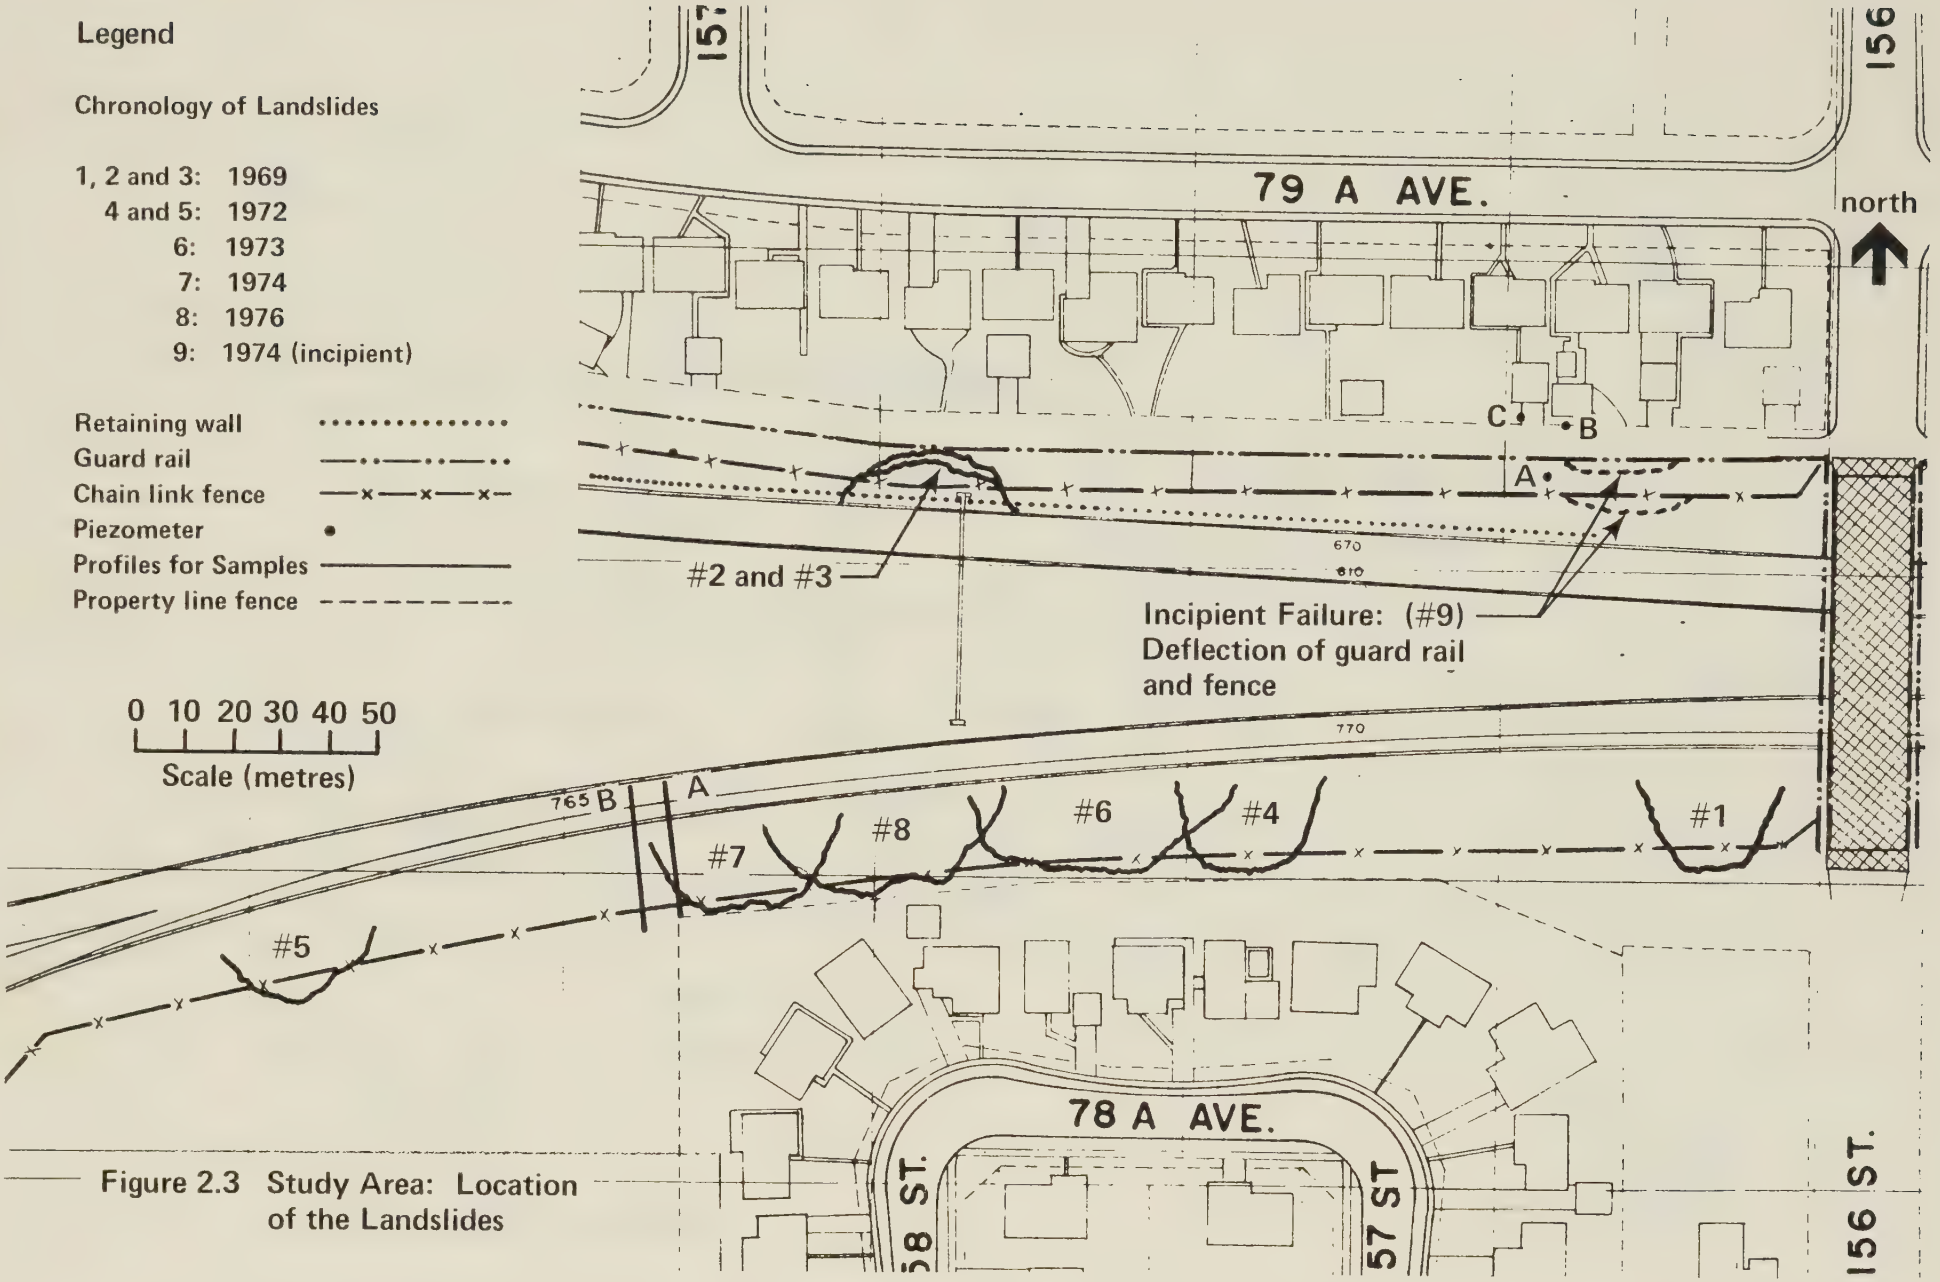
Figure 2.3 Study Area: Location of the Landslides

1. Slope flattening (slide #1, Figure 2.3).
2. Complete excavation of the failed mass and rebuilding the slope with a coarse, pit-run granular material (slide #6).
3. Benching, with the installation of gravel drainage mats on the benches (slides #4, #5, and #7).
4. The installation of a concrete, crib-type retaining wall (slides #2 and #3).
5. The installation of counterfort drains with cast-in-place stitch piles (slide #8).

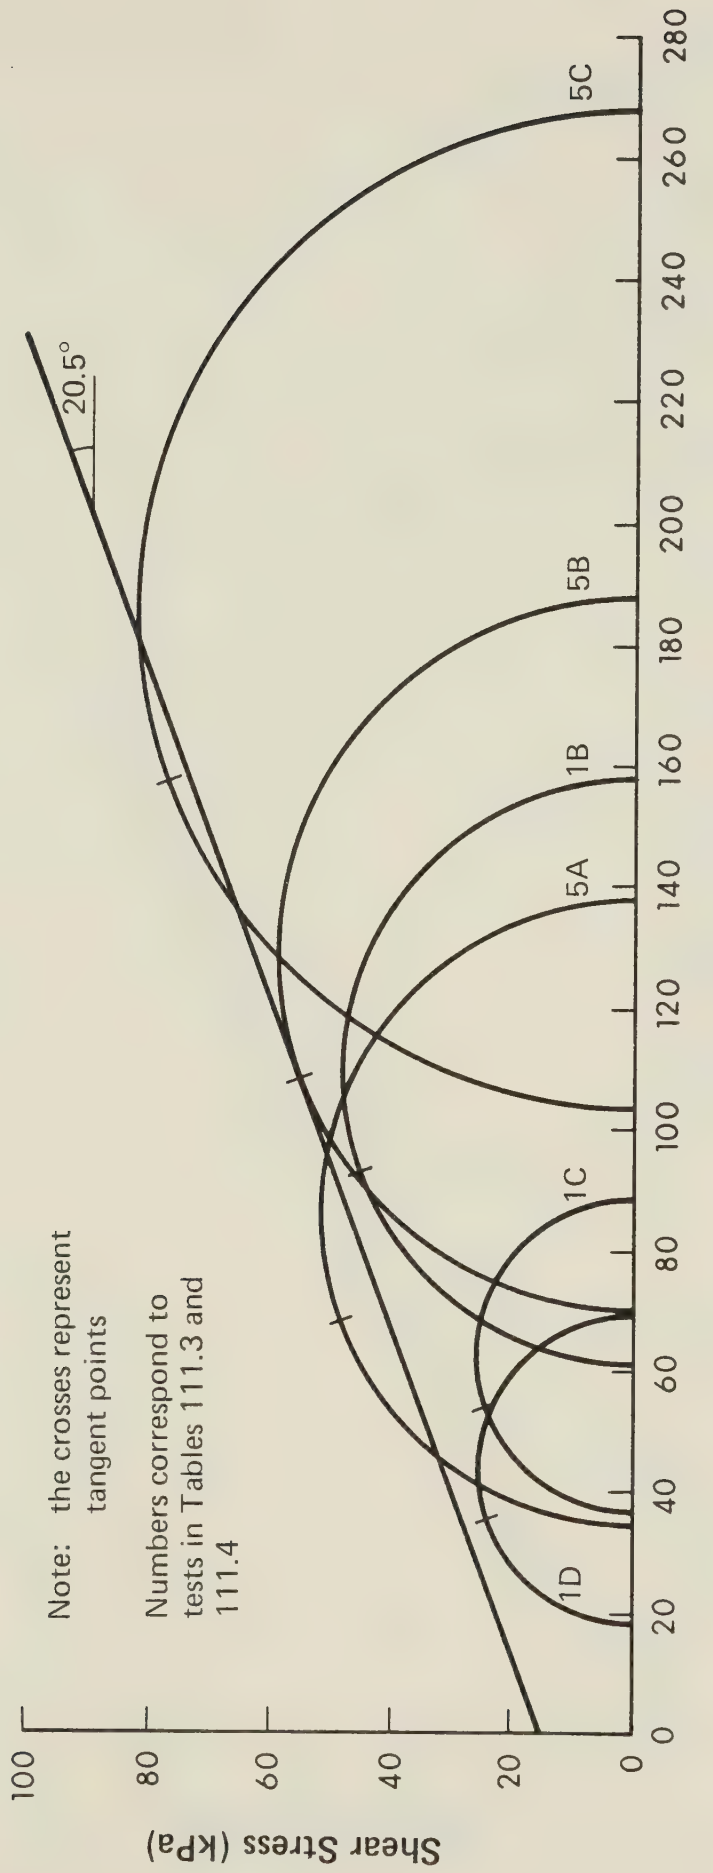
Figure 3.2 Mohr Envelope for 3.8 cm Diameter Intact Drained and Undrained Triaxial Tests

The tangent points for the 3.8 centimetre diameter Intact triaxial tests were determined in the same manner, assuming a c' of 15 kPa and a $\emptyset'$ of 20.5° (Figure 3.2). All tests are in reasonable agreement with the envelope, except for Tests #1c and #1d. Test #1c was observed to have two failure planes at 60° and 45°, and, therefore, it is believed that structural discontinuities may have been involved in the failure. Test #1d could be somewhat low because of a substantial decrease in the membrane and drain correction below normal stresses of about 35 to 40 kPa, as discussed in Section 3.4.3. It can also be noted on the Mohr diagram that the undrained tests have slightly lower strengths than the drained tests. This effect has been attributed to the different energy relationships between the tests (Bishop and Henkel, 1962).

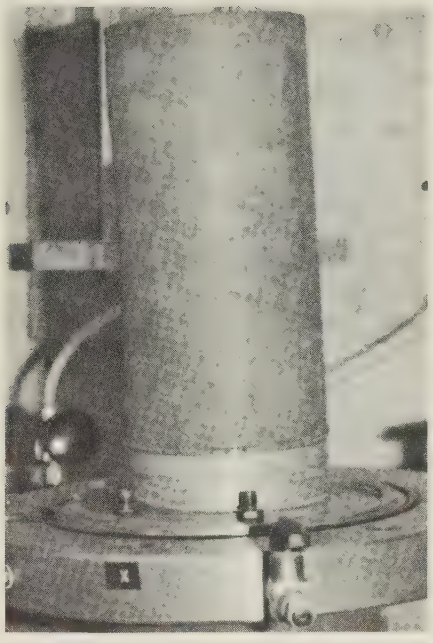
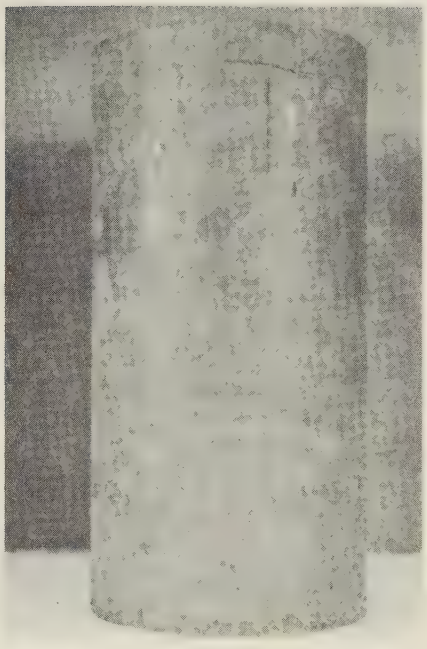
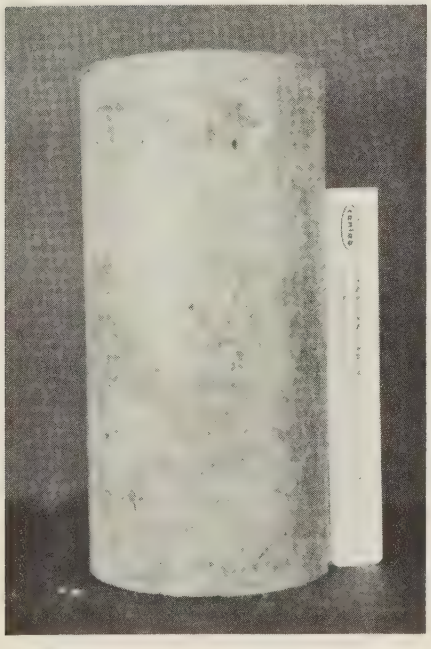
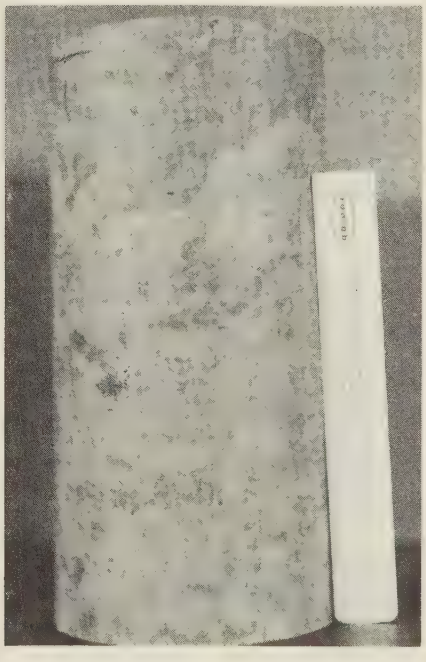
Plate 5 10.2 cm. Diameter Triaxial Test Samples.

Plates 5a and 5b depict two Intact 10.2 centimetre diameter triaxial samples. Upon first inspection, the heterogeneity of the material becomes readily apparent. The overall texture may be described as mottled or marbaloid, with lighter silt lenses or pockets surrounded in a darker clay matrix, or vice-versa. Upon closer inspection, features which reflect the highly disturbed and complex history become apparent. Contorted laminations with complex kink bands can be noted near the base of sample T-42a. The boundaries between the two soil types are erratic but very sharp. Flame and load cast type structures of the dark gray clay in the lighter buff silt may also be noted in the middle to top portion of sample T-42a. In sample T-44a, a general horizontal to sub-horizontal banding of silt and clay may be detected, but this too has obviously been highly disturbed. Erratic pebbles and sand pockets up to one centimetre in size have been detected in samples as well. Apart from textural and compositional irregularities, important structural features in the Intact samples may be noted.

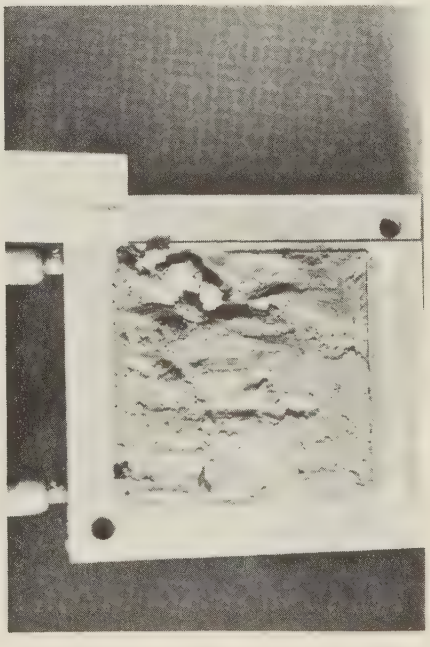
6a Section of triaxial sample T-29(B); Test #3C.

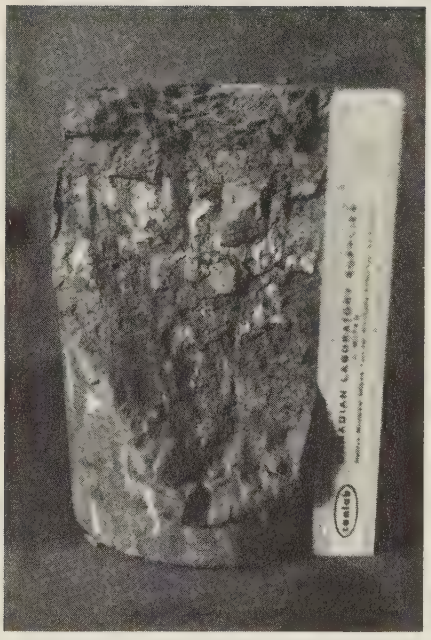
6b Failure plane of triaxial sample T-43(C); Test #3.

6c Failure plane of direct shear sample T-34(A);Test #5.

6d failure plane of direct shear sample T-39(A);Test #8.

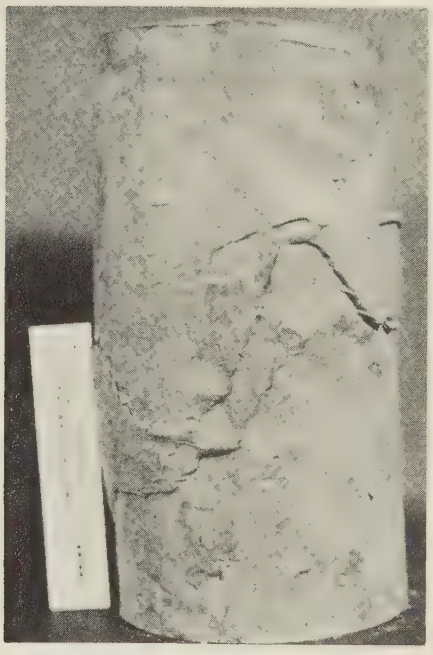
7a Failure plane of sample T-38(A);Test #6.

7b Sample T-39(A); Test #9.

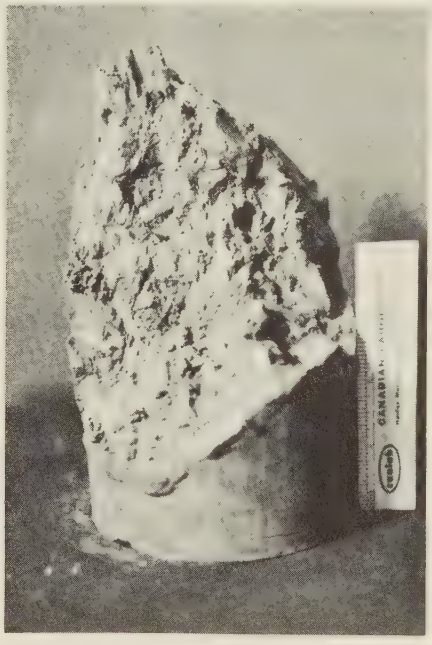
7c Bottom section of sample T-39(A).

7d Top section of sample T-39(A).

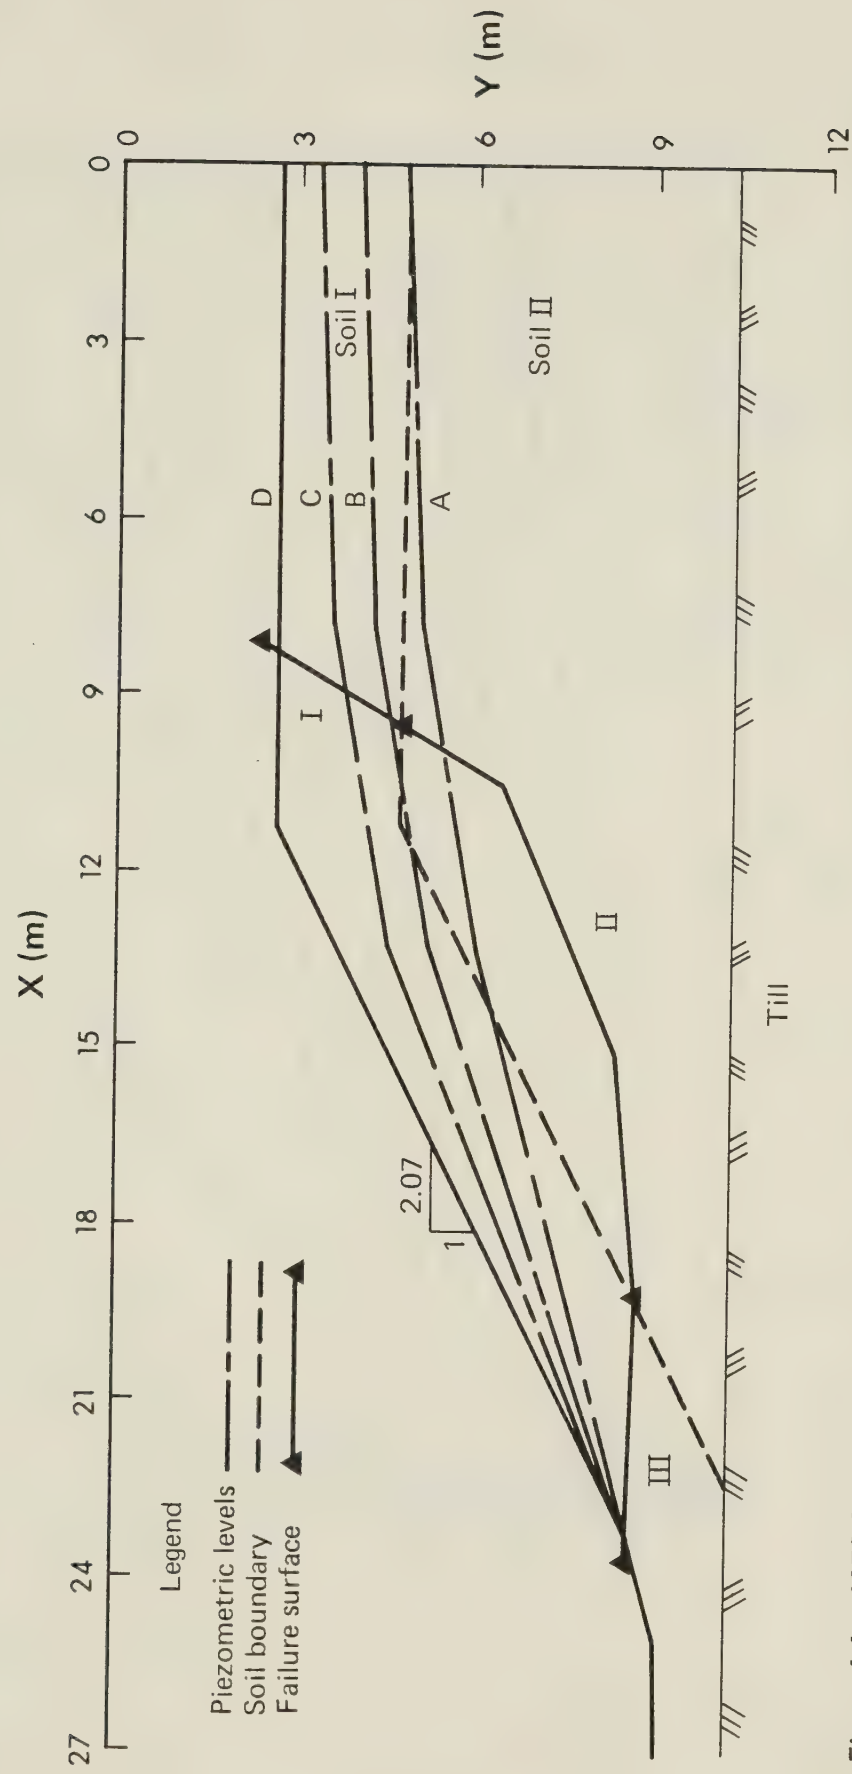
Figure 4.1 1973 Slide: Non-Circular Slip Analysis Profile

The profile used for the analysis is depicted in Figure 4.1. The configuration of the ground surface and failure plane was determined using the survey, borehole and toe trench data presented in Chapter II (Figures 2.4 to 2.7). Two soil types have been specified on the diagram, with the division approximately 2.3 metres below the preslide ground surface. The upper layer represents the zone of intense physical weathering after the cut had been excavated. The

1977). Therefore, to assess fluctuations in the water table in the stability analysis of the 1973 slide, a series of piezometric levels were investigated, ranging from a depth of about 2.1 metres below the surface at the crest of the slope to the ground surface (Figure 4.1). Correlations of slope instability with the Edmonton precipitation records (Appendix B) have also been drawn, and are presented in a following subsection.

Notes: N.C. means not converging.
I, II and III correspond to zones on Figure 4.1.
